Two case history of EMS data application: earthquake in central italy and flooding in Piedmont region

Luca Lanteri*, **Rocco Pispico***, **R. Cremonini****

*Arpa Piemonte, Geological and Natural Risk Dipartiment

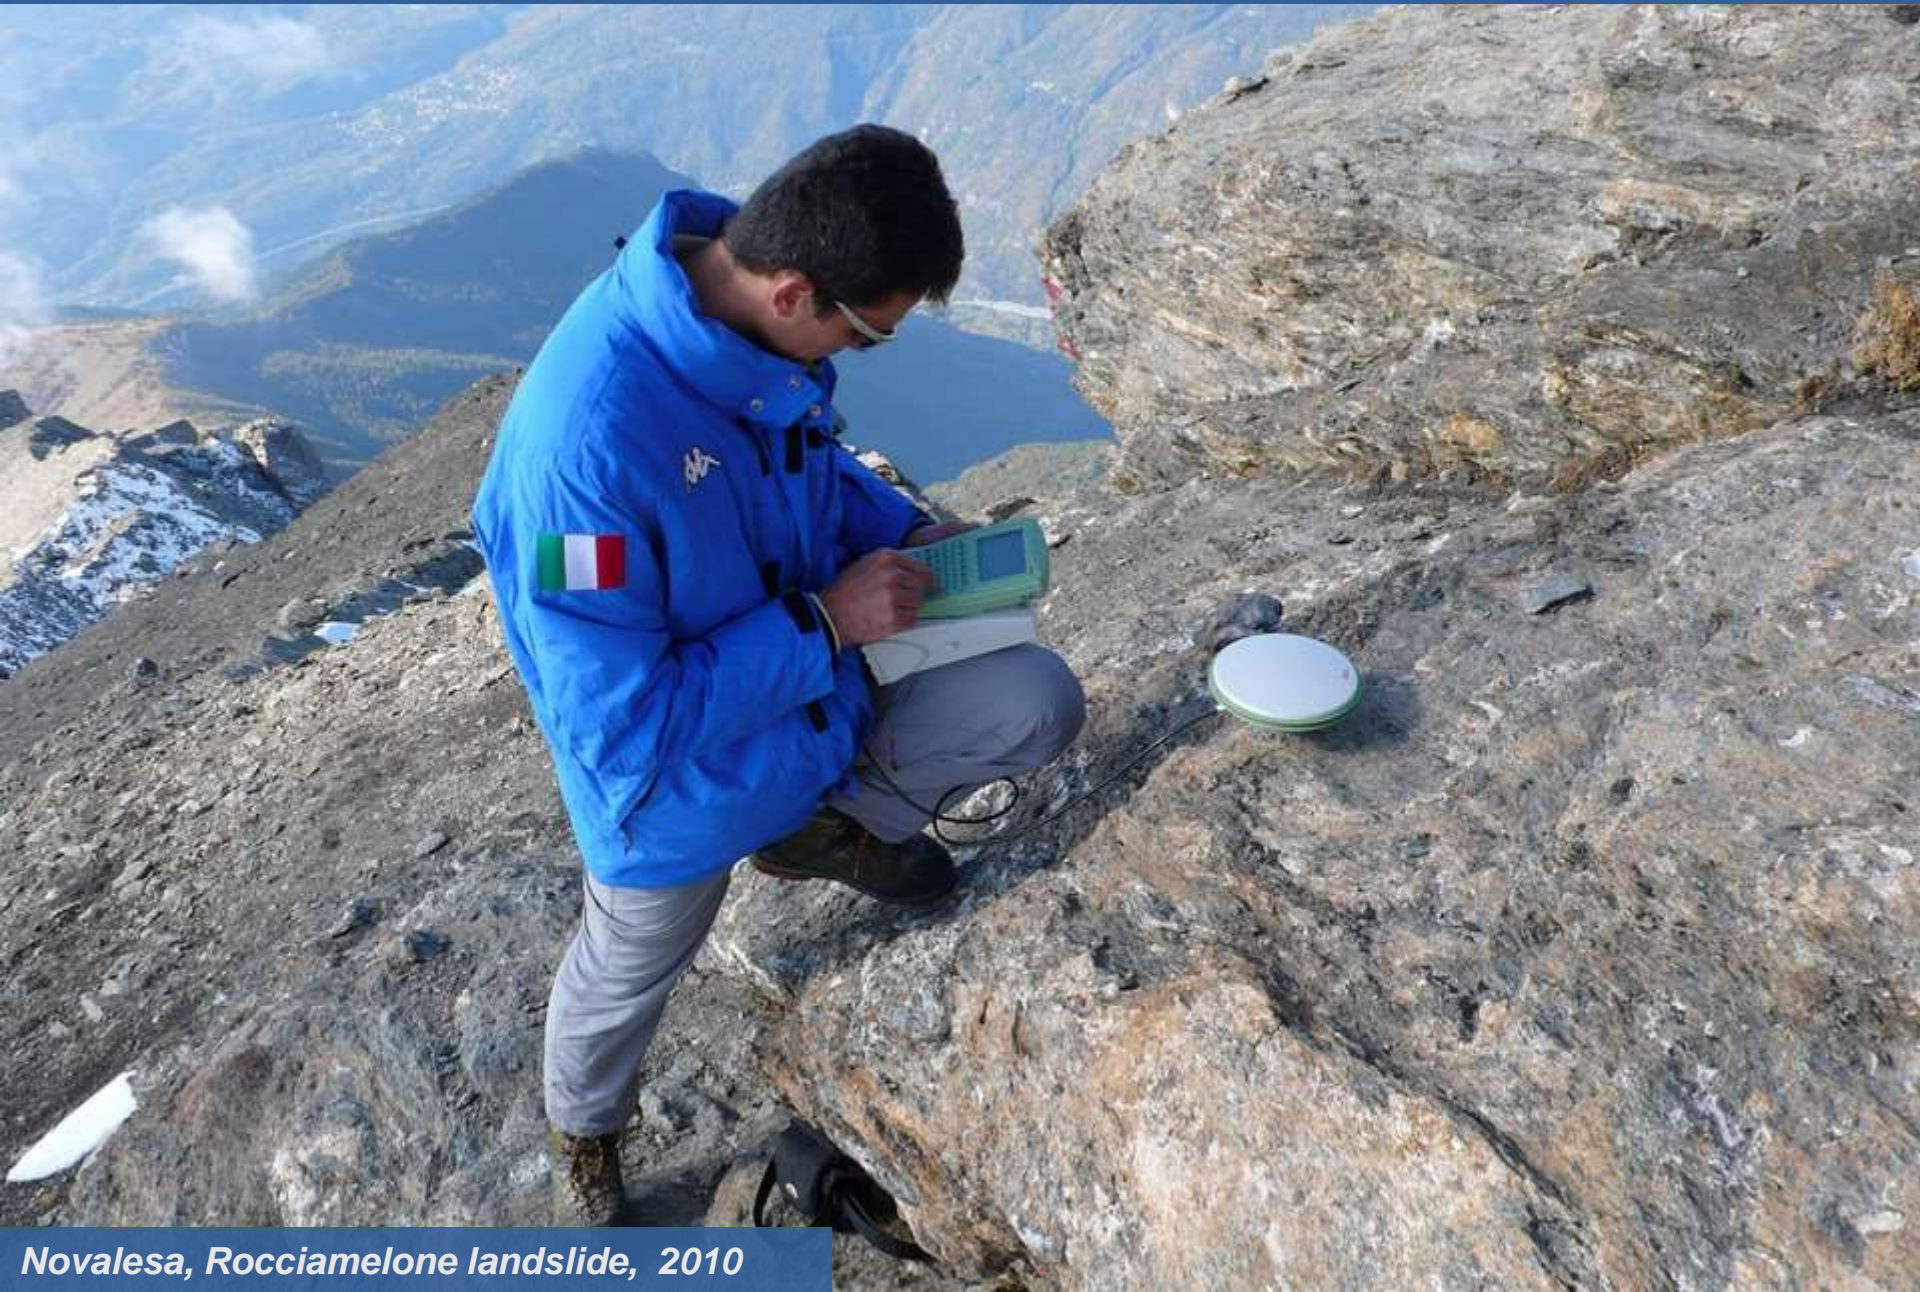
Novalesa, Rocciamelone landslide, 2010

Manage of monitoring landslides networks

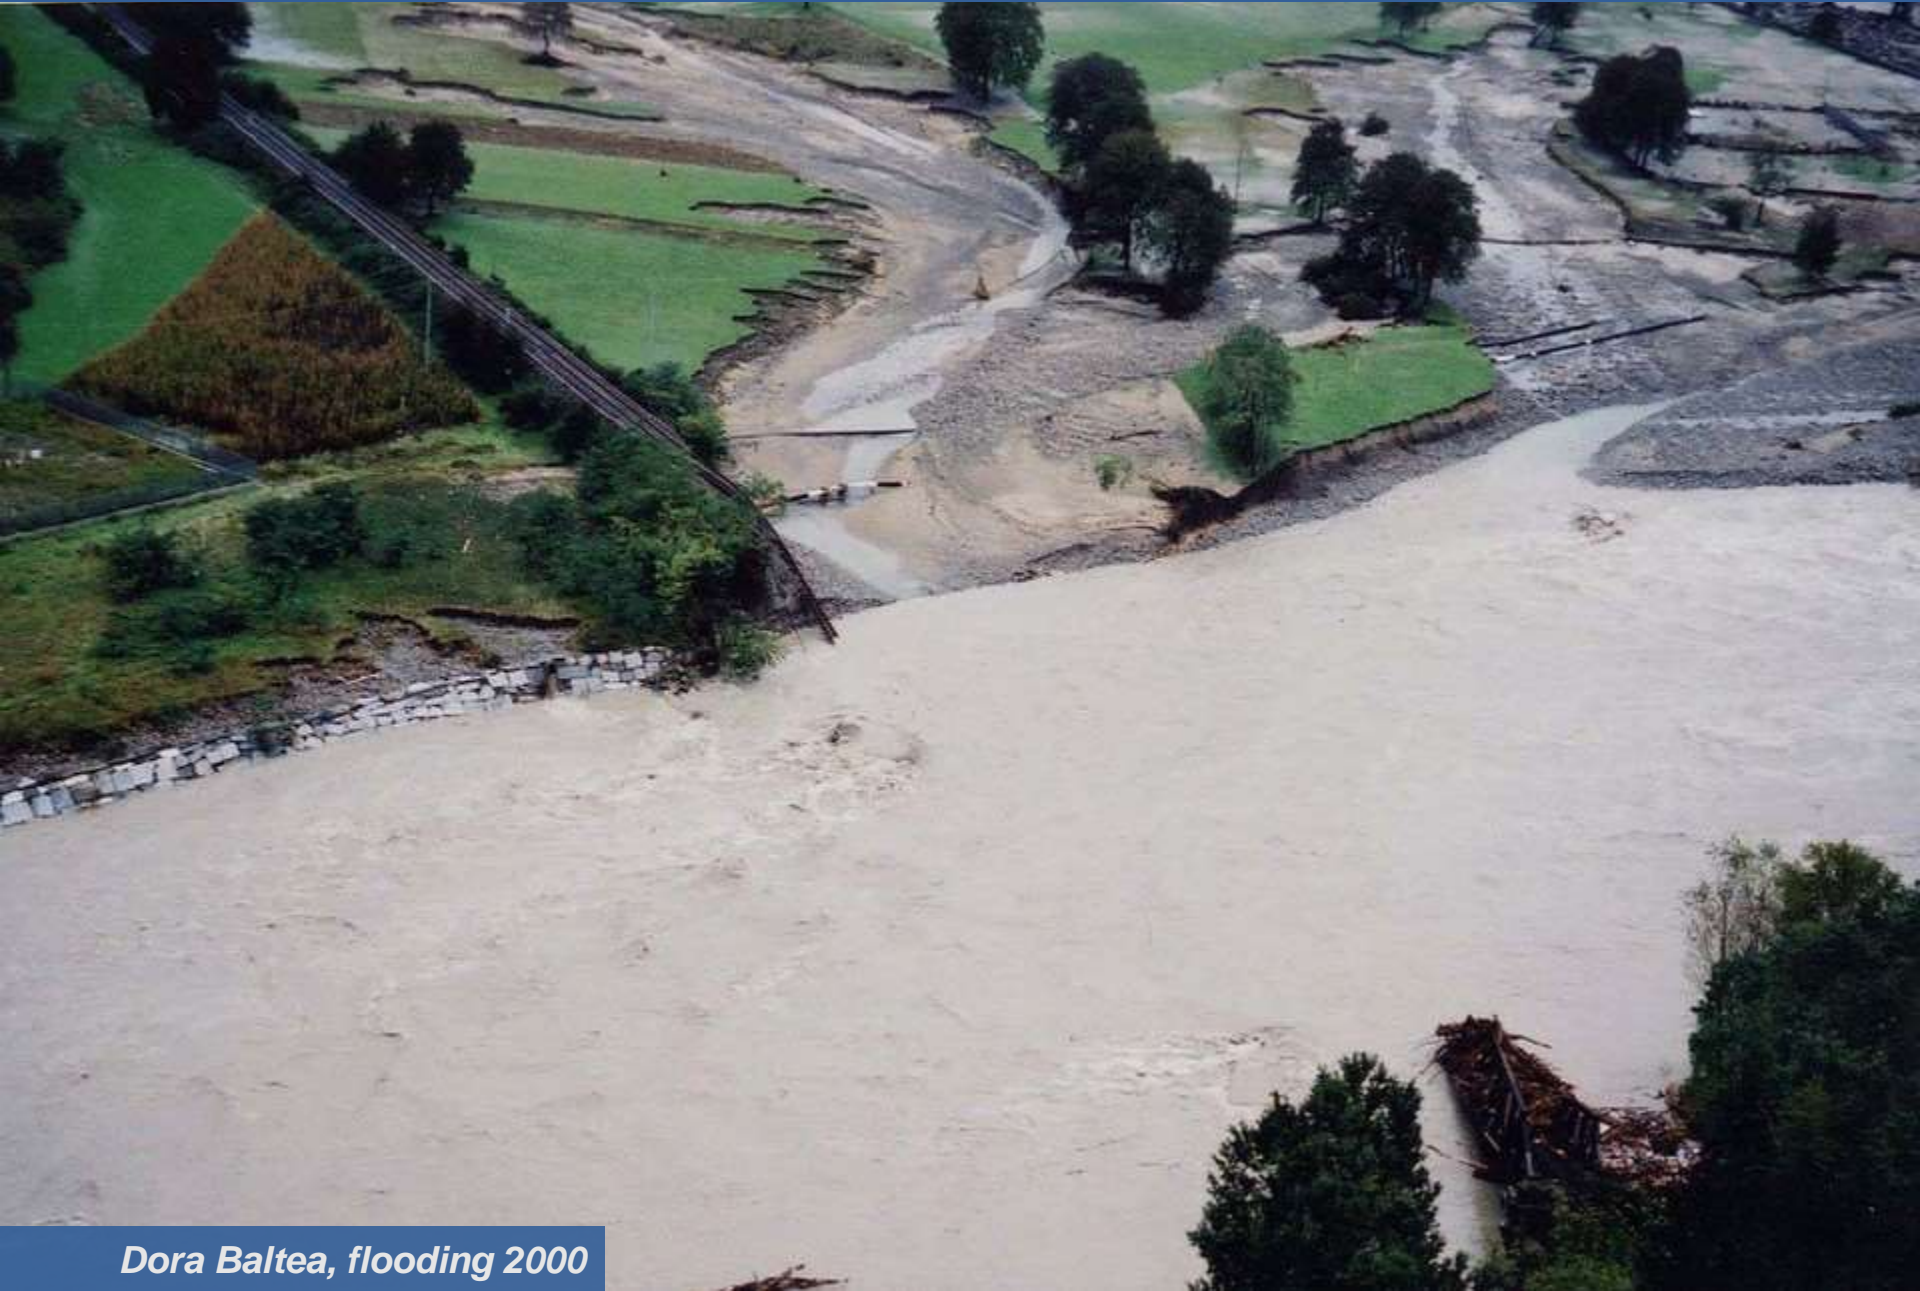
Dora Baltea, flooding 2000

Survey and data collection after flooding events

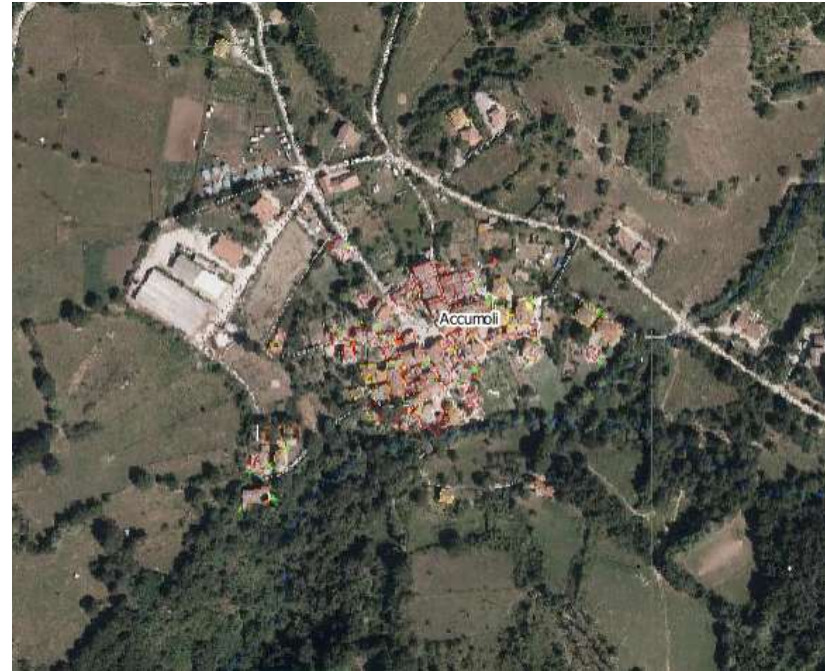
- ✓ *Municipality Coordination Center (COC) use Tile Map Service as the most updated base cartography (where available) for QGIS (ERIKUS project)*
- ✓ *Experimentation to compare grading information from EMS with field survey (AEDES and FAST forms) in perspective for future events*

Use of products: 24 august earthquake. Data comparison

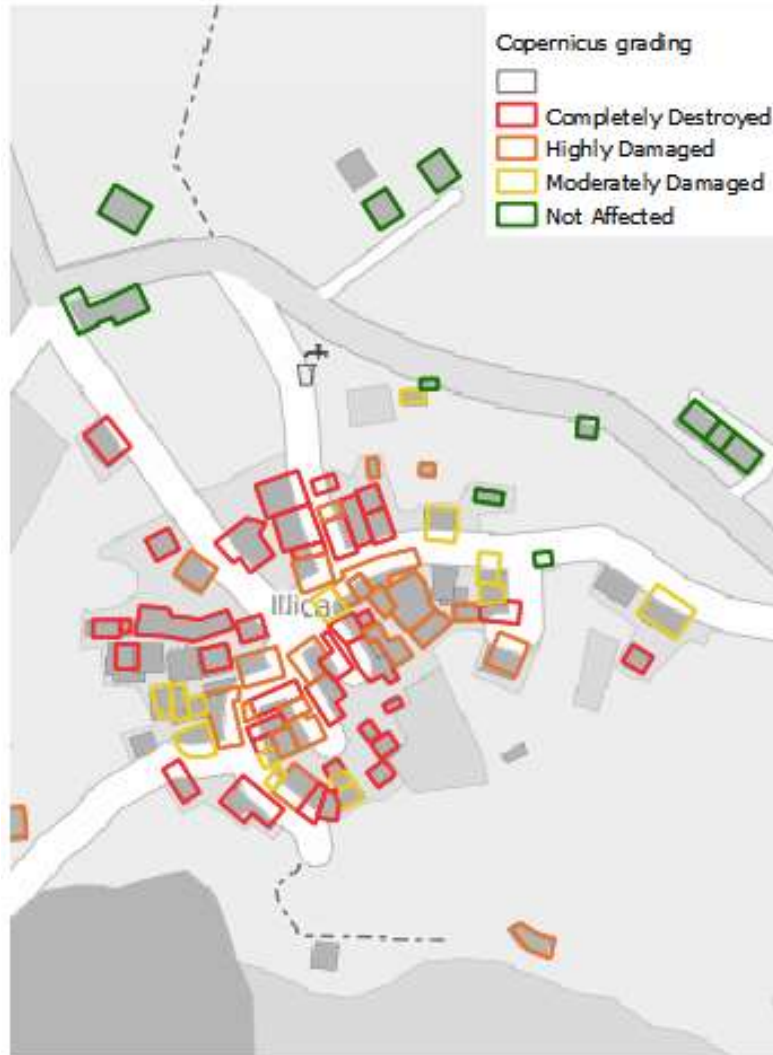
Illica - Accumoli

Percentage of success on:

- Damaged building 90%
- Moderately affected 5%
- Not affected 30%

TOTAL SCORE 65%

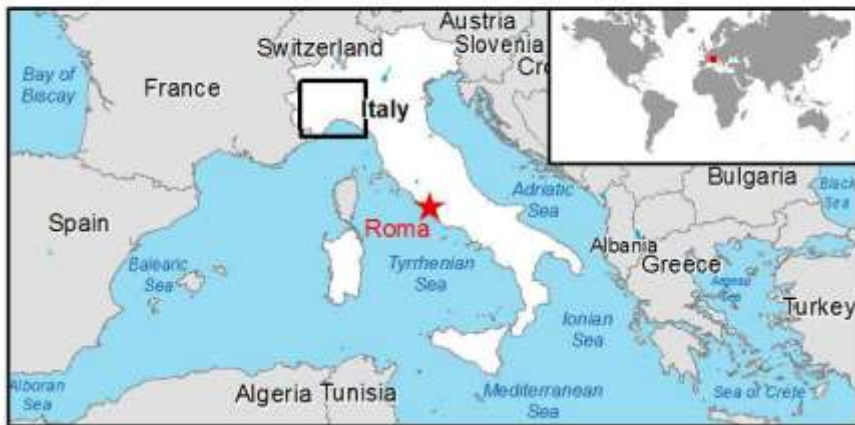
Flood - last updated 02/12/2016
Activation Extent Map

Use of products: 21-26 november 2016 flood

Starting from November 22nd, heavy rainfalls are involving the territory of North West of Italy, in particular the Regions of Piemonte and Liguria. The bad weather conditions and the persistence of precipitations have caused the increasing of hydrometric levels of all the rivers in particular in the basin of Po river.

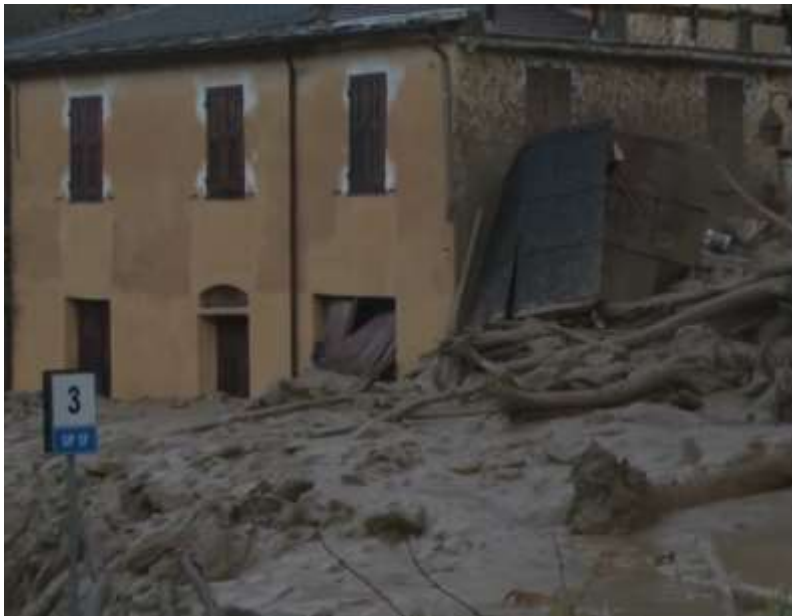
— Radarsat-2

Location: Bormida Valley

Map type: Delineation

Platform: Radarsat-2

Imagery date: 2016-11-27 16:37

Other data:
Airborne photo
Field survey

Analyzed area: from Sezzadio to Alessandria (about 18km)

Flooded area:

Field survey 21,39 sq km

EMS 5,82 sq km

EMS/Field survey = 27,2%

Low flooded area detected

Area with water 4 days after no detected

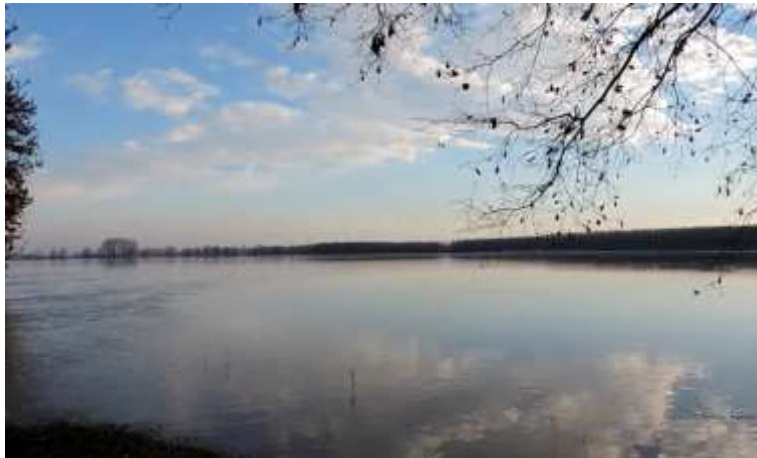
CRESCENTINO PO (VC)

Location: Po Valley, from castagneto to crescentino

Map type: Delineation

Platform: Radarsat-2

Imagery date: 2016-11-25 16:37

Other data:
CIMA flooded areas
Field survey

Po flooded area from Castagneto to Verrua Savoia (about 13 km)

Field survey 18,8 sq km
EMS 7,7 sq km

EMS/Field survey
40,9%

Georeferencing difference about 100m

Cima and EMS elaborations have a good match (same area identified as flooded)

Both have a good match with field survey

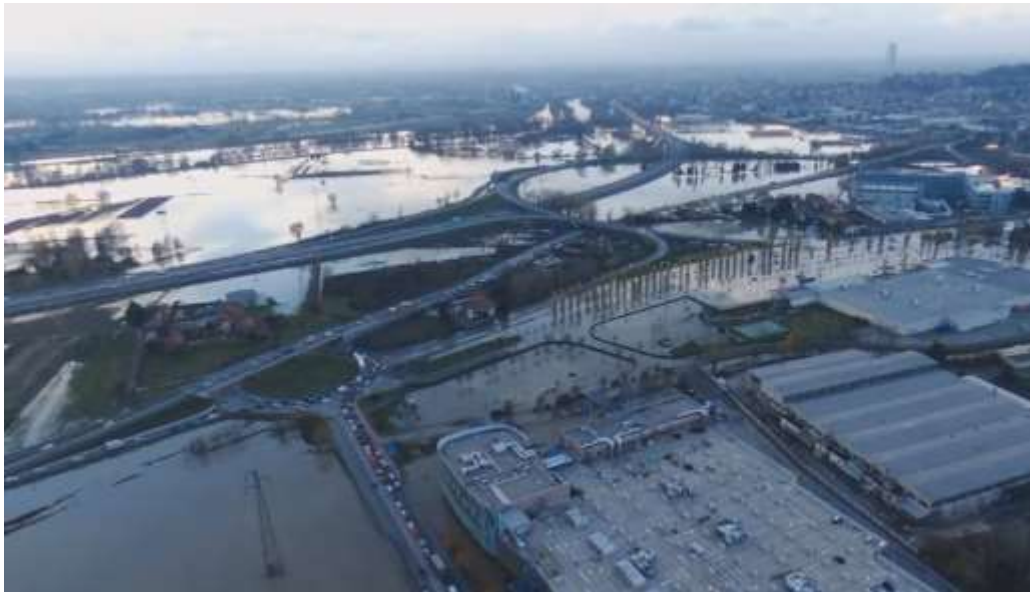
Location: Chisola-Po confluence (Moncalieri & Turin Municipalities)

Map type: Grading

Platform: *Pleiades (very high resolution optical data)*

Imagery date: 2016-11-27 16:37

Chisola - PO Flooded at N of Highway

Field survey 9,2 sq km
EMS 5,3 sq km

EMS/Field survey
57,6%

High match form EMS, CIMA and Arpa survey

No false positives (all areas indicated as flooded confirmed by field survey)
